## Repairing a Yamaha CR-620 Amplifier

**Product:** Yamaha CR-620, Natural Sound Stereo Receiver

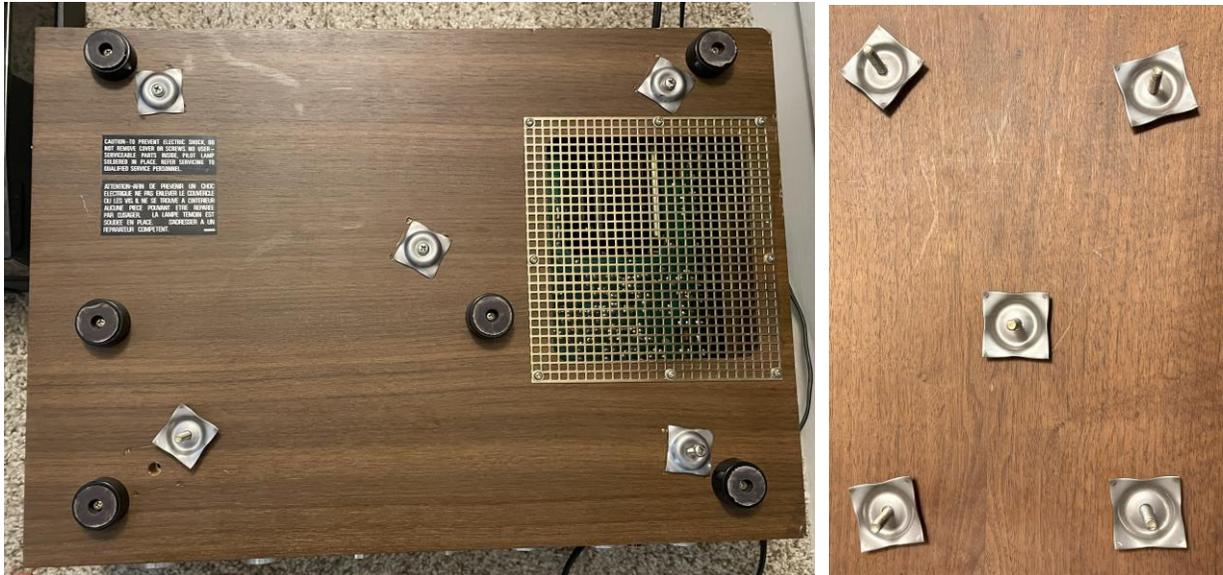
**Figure 5.** (Left) Bottom View. Silver Fasteners are what holds the electronics panel to the wood housing.  
(Right) Silver Fasteners with screws removed

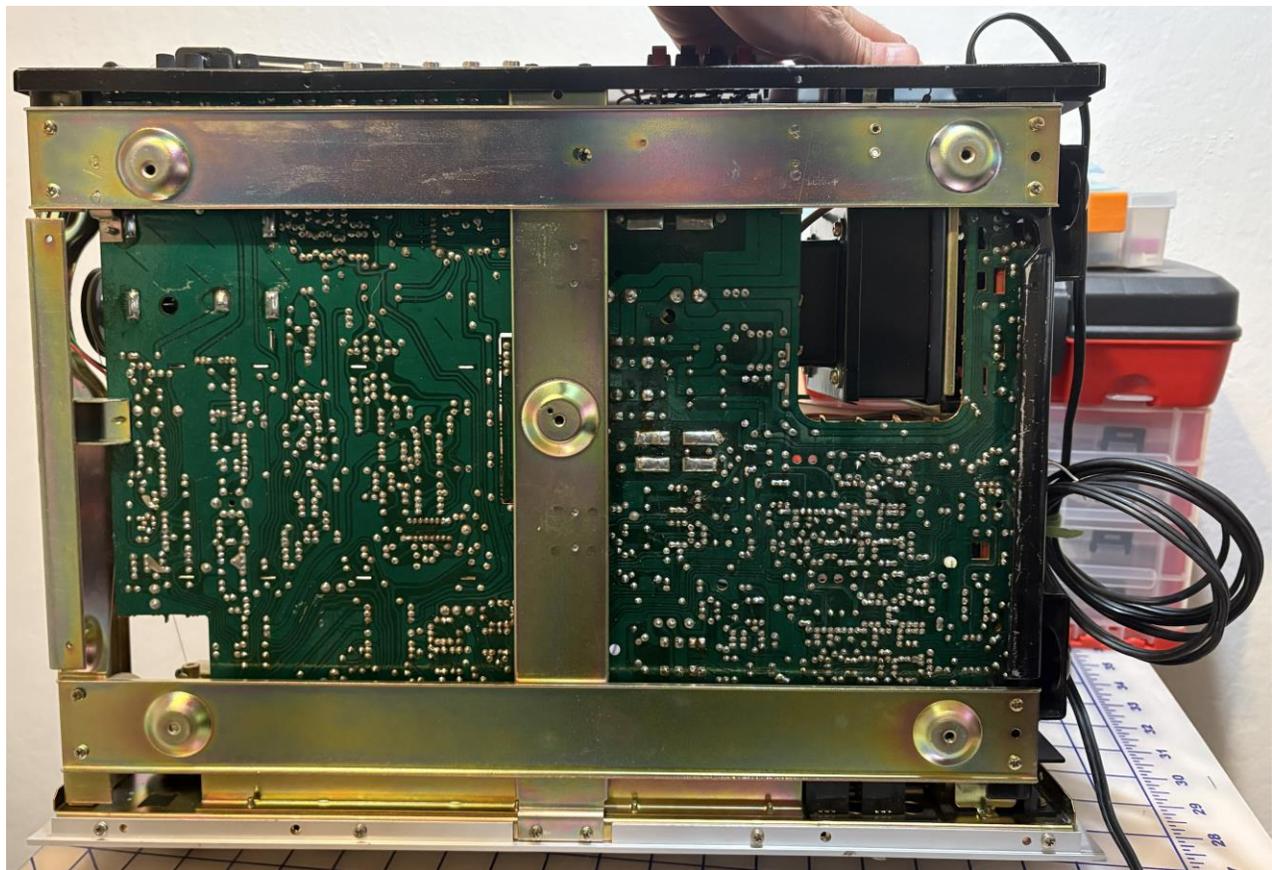
**Figure 6.** Bottom View of the Amplifier removed from the wood housing. Electrical housing shown will expose bottom of PCB. SMD soldered connections can be seen and accessed from the bottom.

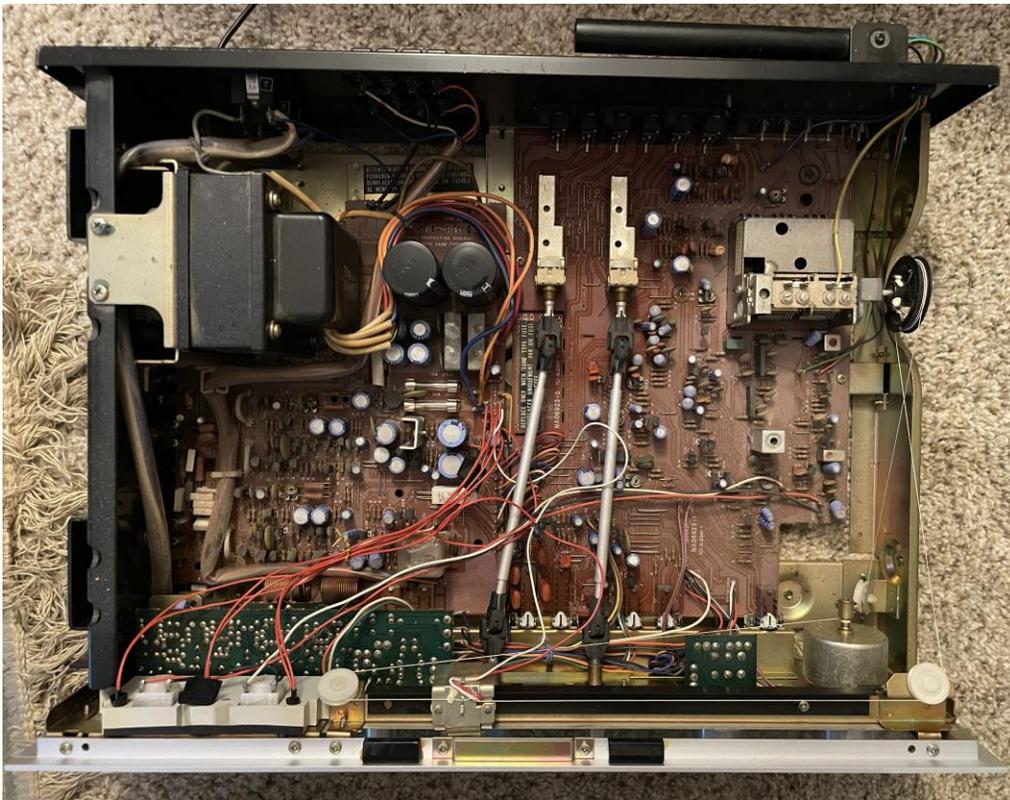
*Figure 8. Top View of the exposed Electrical Panel*

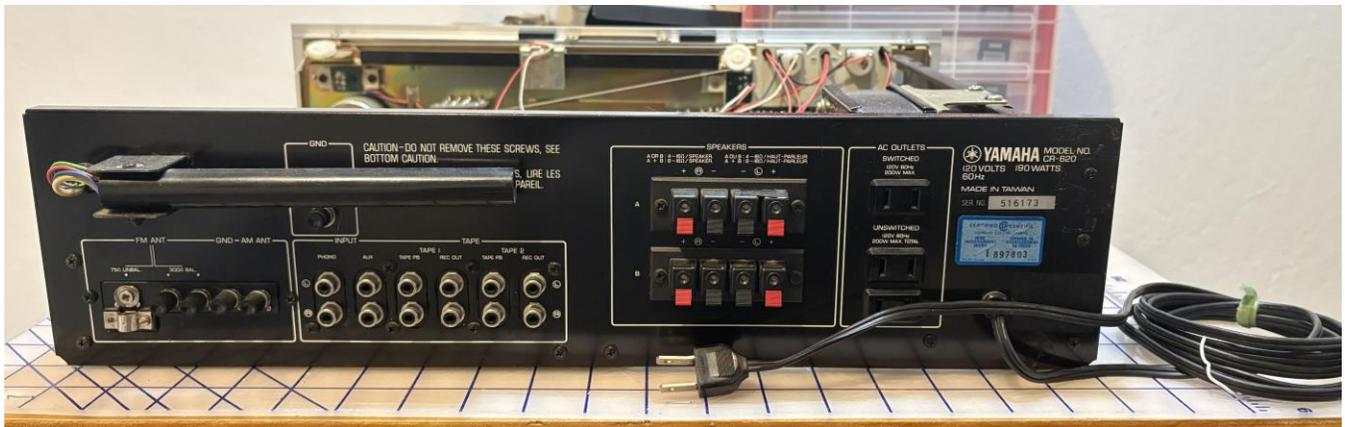
*Figure 9. Back View of the Amplifier w/o wood case.*

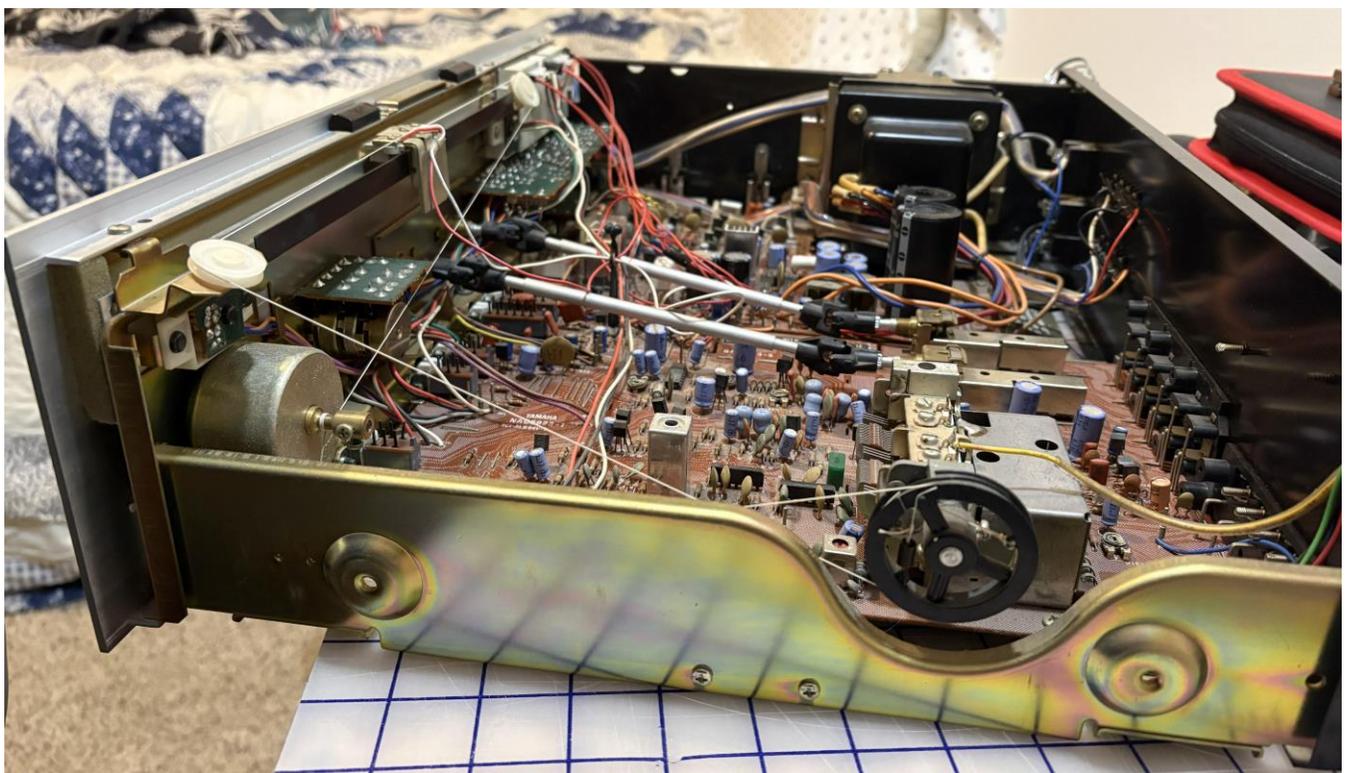
*Figure 10. Side view of the Amplifier w/o wood case.*

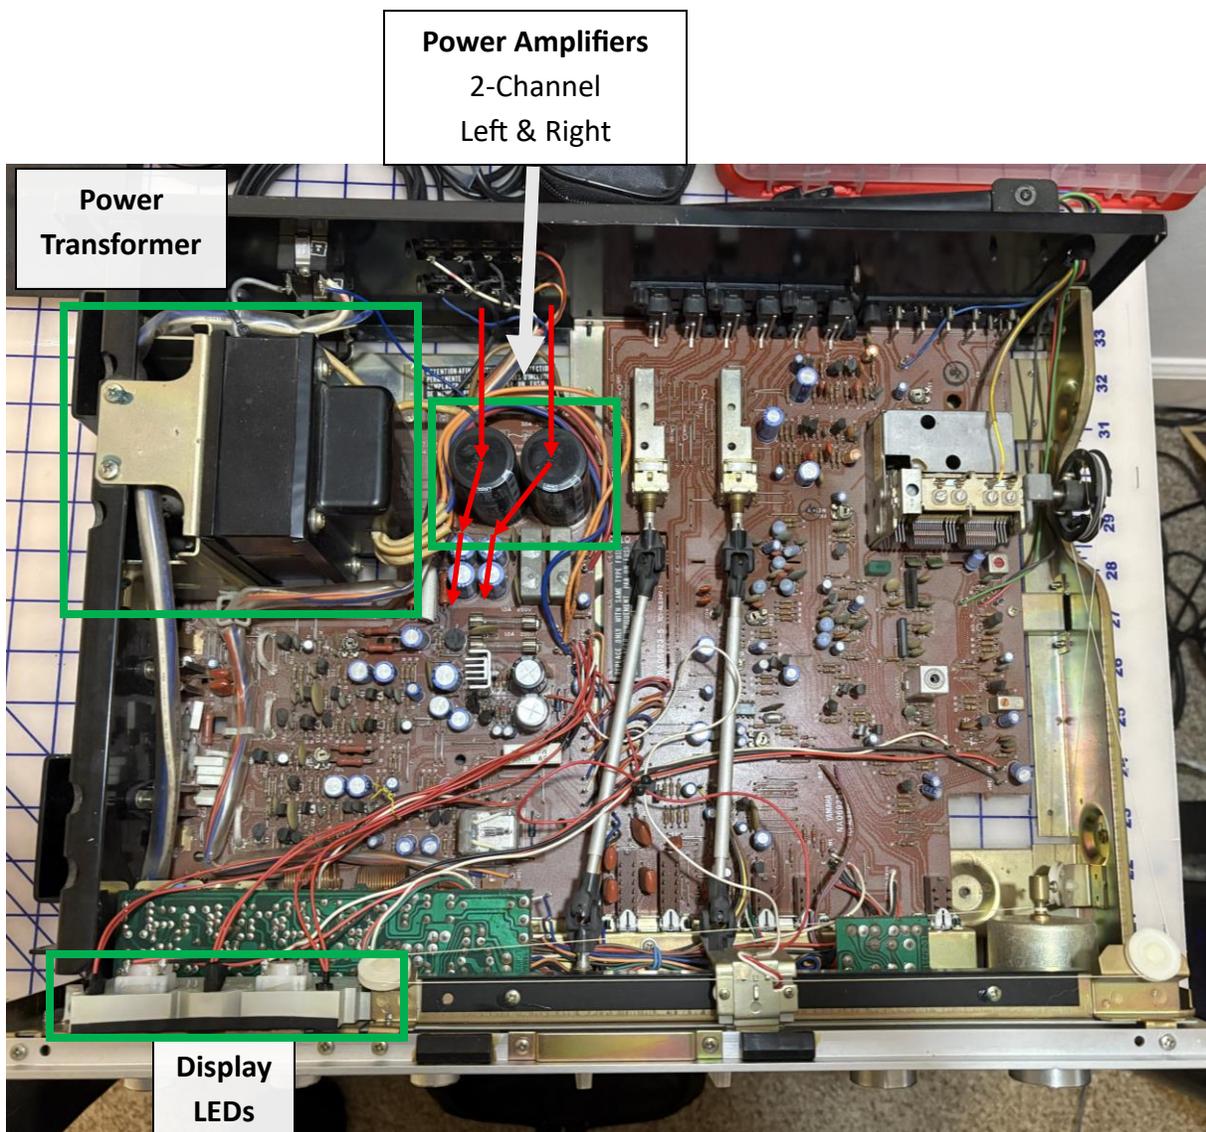
What impressed me so much about this product's design is that there are absolutely no digital components. Taking apart any electronics from the 2000's onwards, you will find programmable circuit boards (PCBs). In modern amplifiers, most of the sound amplification and tuning is done by digitizing the data (discretizing) and then by amplifying the digitized data. In this amplifier, the sound waves, converted to electrical current, are amplified by a complex series of capacitors, resistors, and transistors.

*Figure 11. Amplifier electrical board shown from Top View. Major components are labeled.*

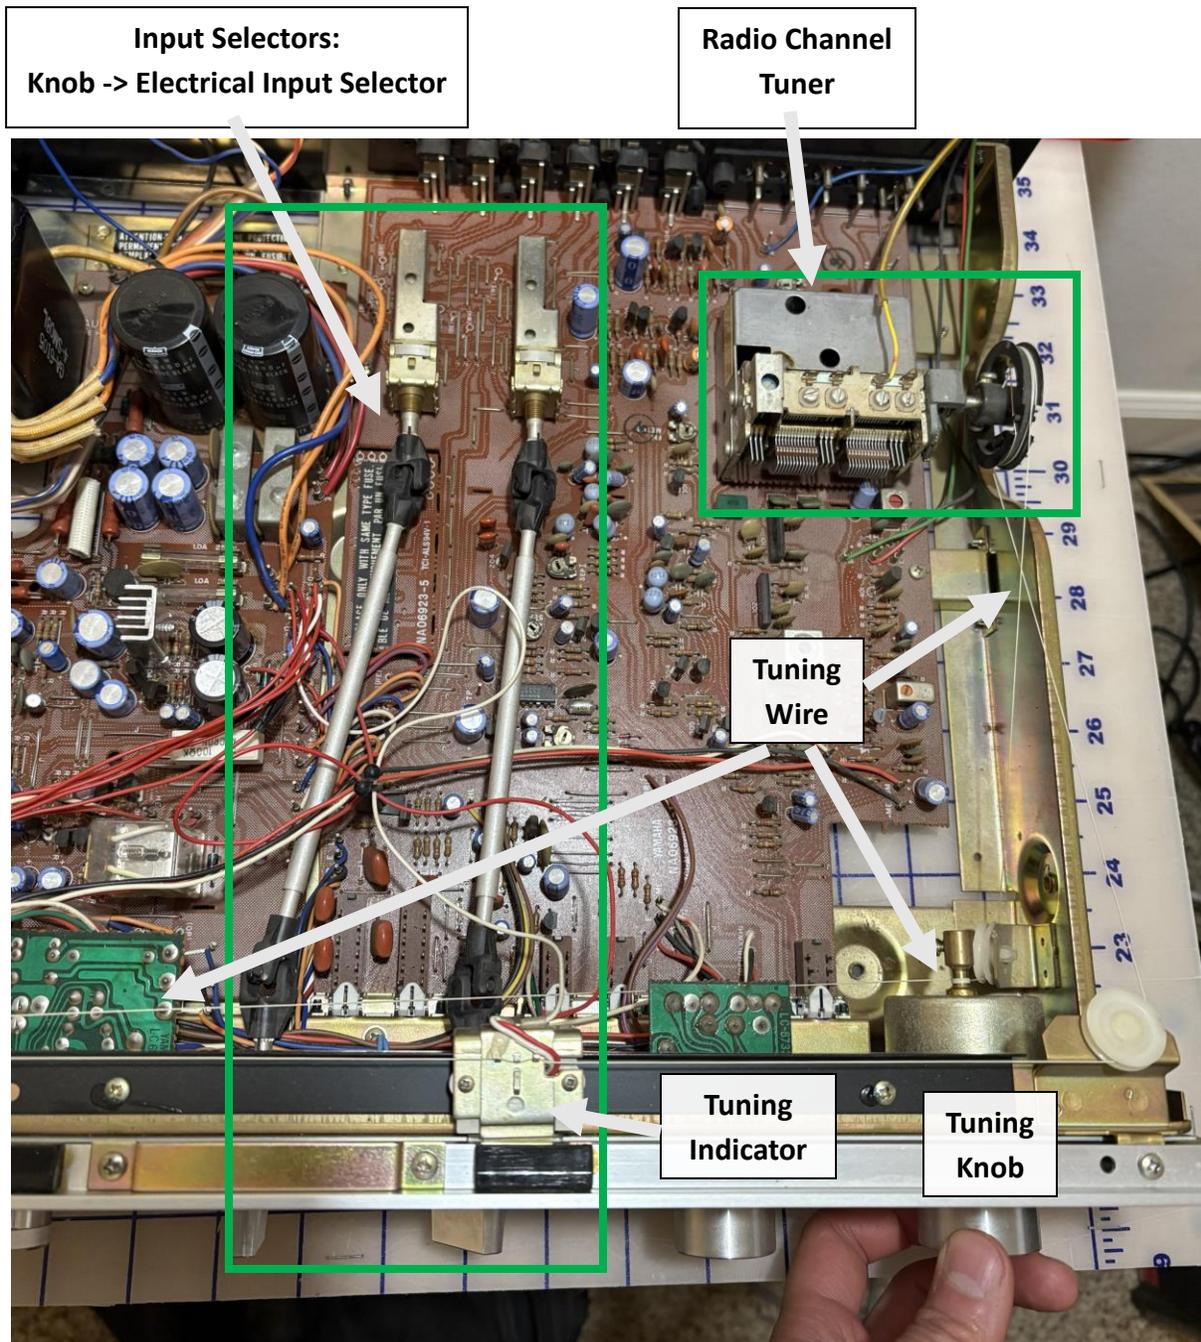
Additionally, the mechanical components in the amplifier, such as the Radio Tuner and the Input Selectors, are purely mechanical systems, with no electrical motors. The Radio Tuner is literally concocted by running a piece of string/wire around the amplifier in a loop leading to the radio frequency tuner. The Input Selectors utilize 8" rods, with couplings on each side to connect the knobs to the electrical input selector.

Figure 12. Amplifier electrical board shown from Top View. Mechanical Components Identified.

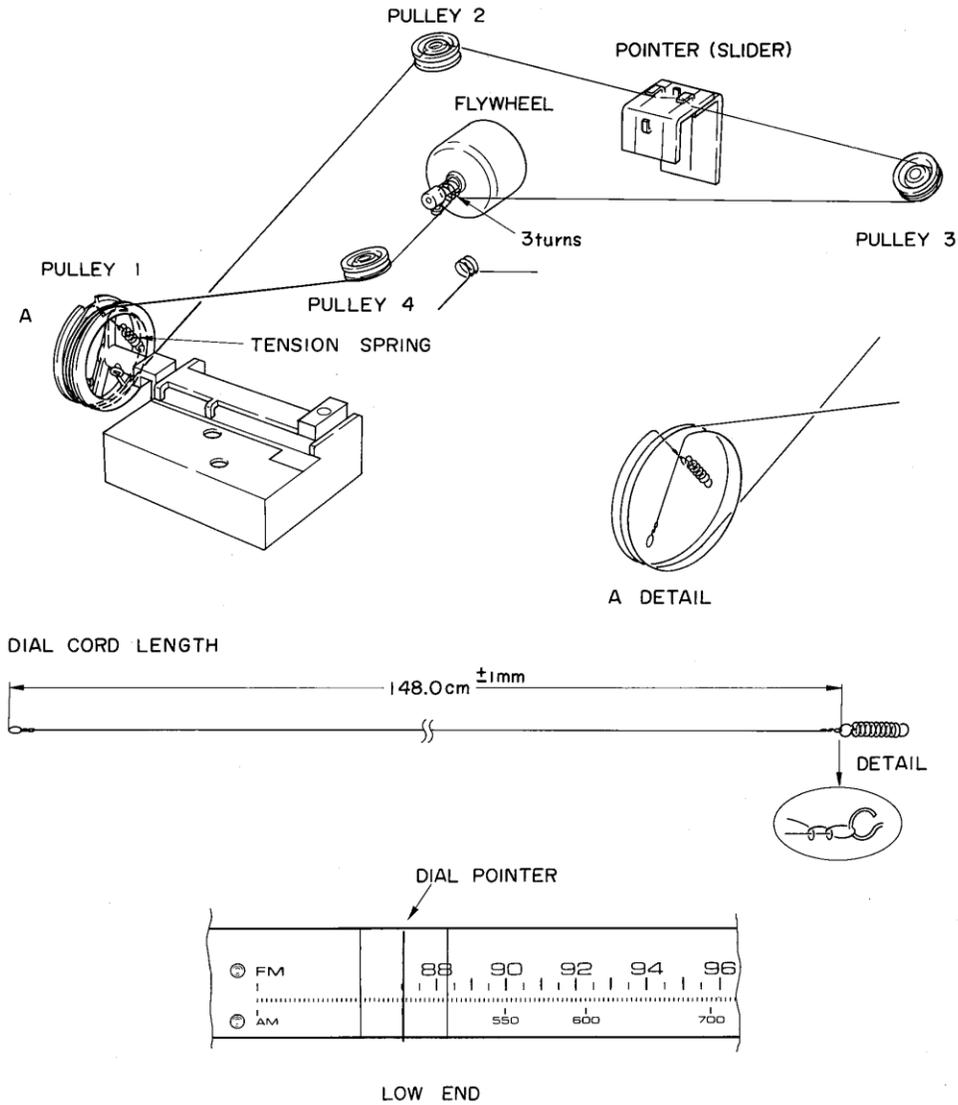
### DIAL CORD STRINGING

After dial cord stringing, turn the tuning knob fully counterclockwise and set the pointer to lower end indication of the scale as illustrated above. Then hook the string to the pointer assembly and lock by painting.

Figure 13. Diagram showing how the mechanical Radio Tuner Dial works.

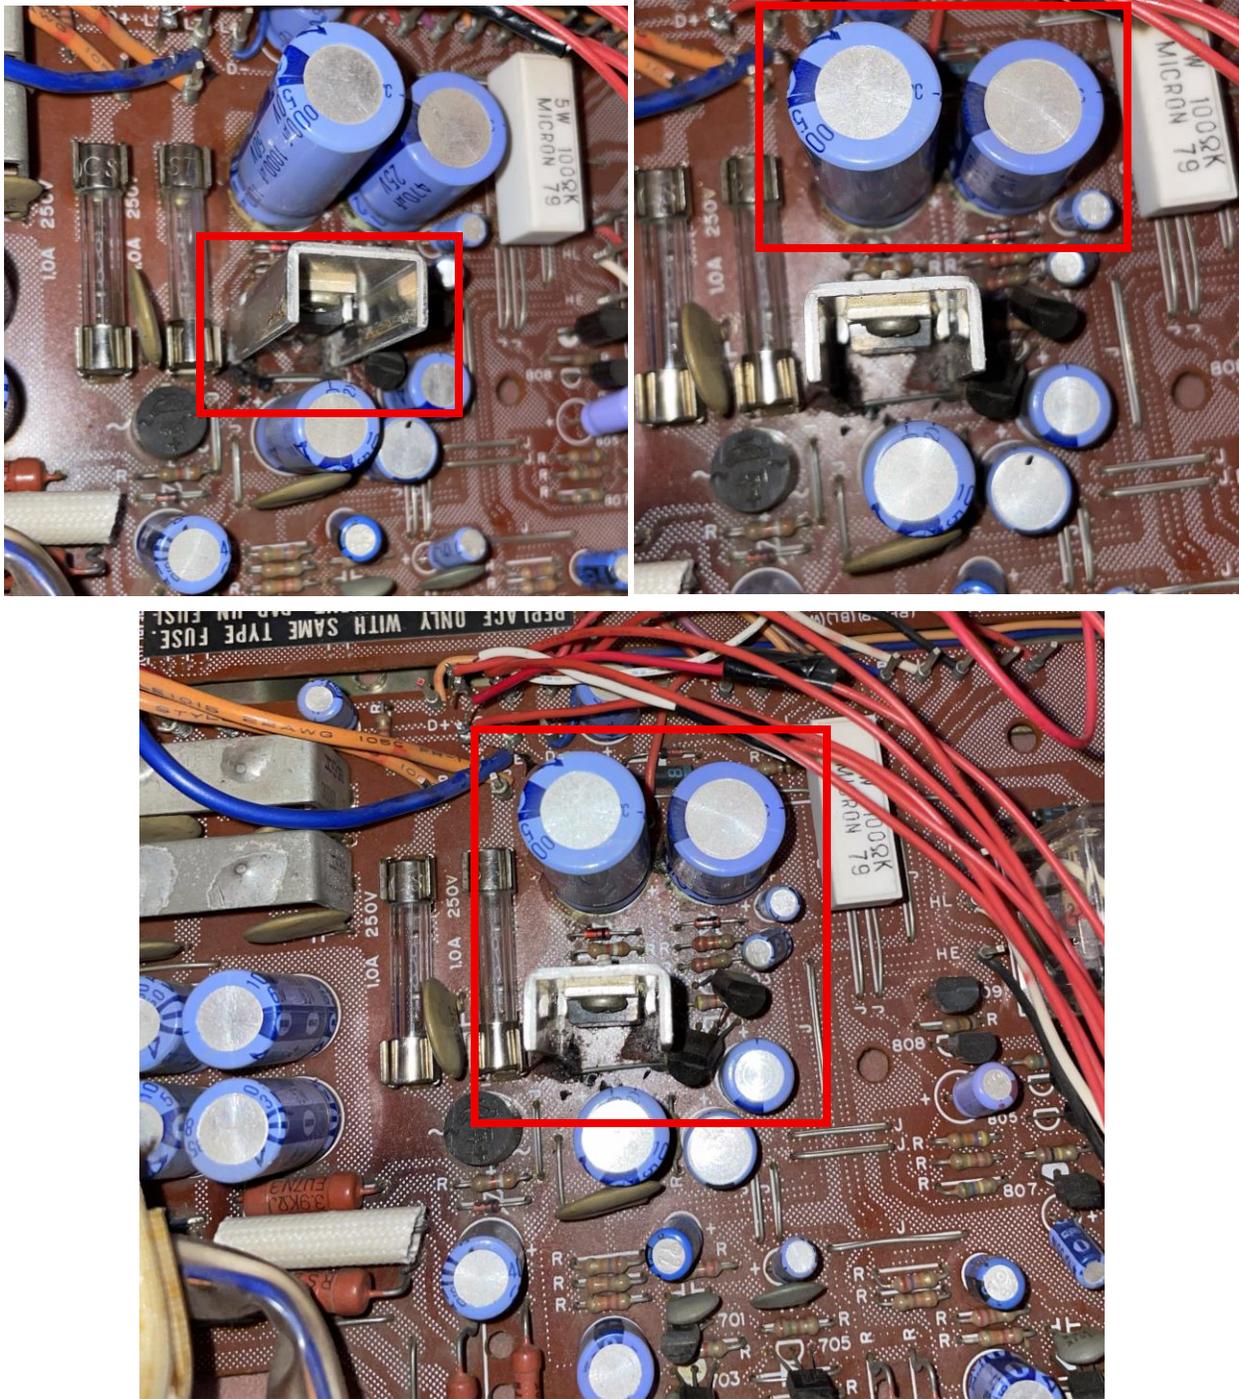
I took apart the amplifier to check the internals and found it really interesting. I ended up digging up the wiring schematic for the machine and tried replacing couple of components that looked damage: PCB discoloration due to overheating and some corrosion on some SMD. At this time, the unit is still experiencing the issues after replacing some parts, but I plan to dig into it some more when I have some free time. In this report, I will be documenting some of the interesting finds.

*Figure 14. Some Electrolyte leak seen around the two blue electrolytic capacitors. Burnt substrate seen around the transistor mount.*
